Invoice No	: RE/GST/24-25/077	Place Of Supply	: Tamil Nadu (33)
Invoice Date	: 11/11/2024		
Terms	: Net 15		
Due Date	: 26/11/2024		
WO.#	: TFSCPL/AMC/2023-24/16

ANNUAL MAINTENANCE CONTRACT AGREEMENT

KITCHEN DUCT CLEANING REPORT

Main Kitchen Area

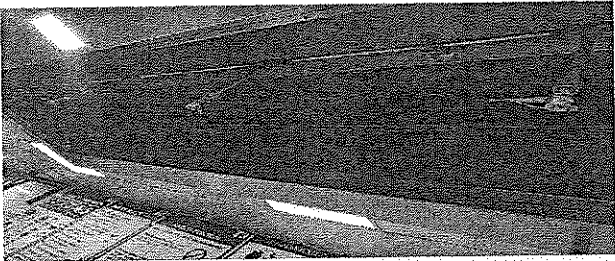
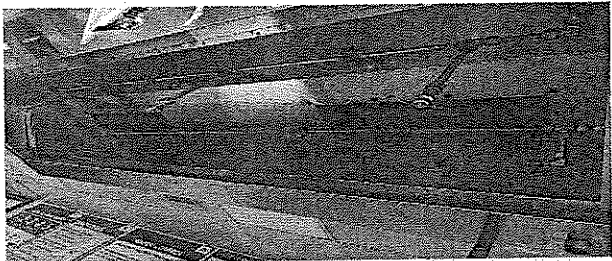
HOOD 1

Before Cleaning

After Cleaning

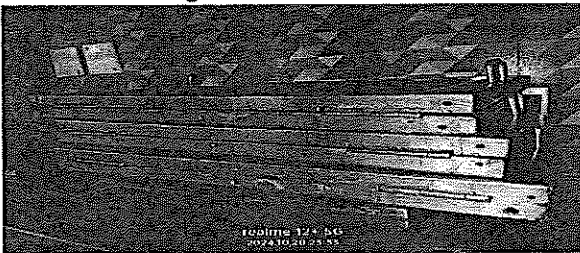
Before cleaned grills

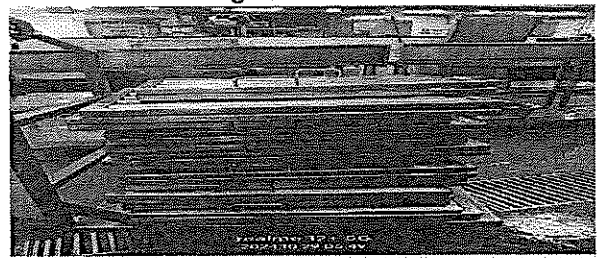
After cleaned grills

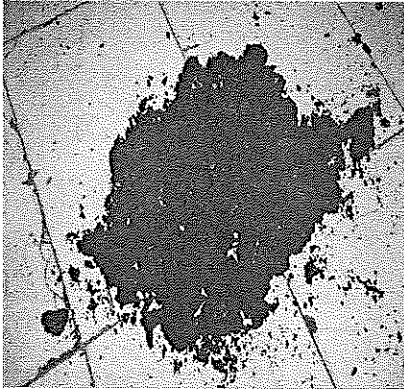
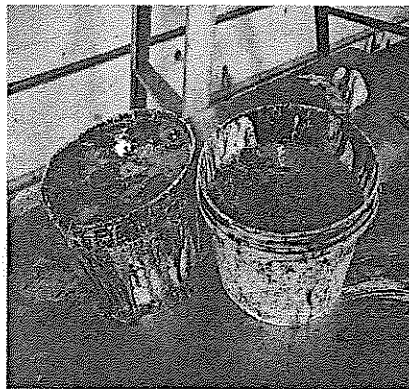
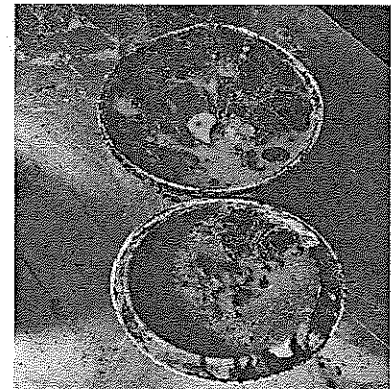
Observation Photos on Duct Cleaning Process:

- High Level of Oil, Grease and Dust particles accumulated inside the ducts, hoods, and exhaust blower of the kitchen.

- All kitchen exhaust ducts & blower were satisfactorily cleaned.
- The duct cleaning works were verified by post-visual inspection.
- The kitchen exhaust cleaning works were also validated by using photographic before and after.
- The results are shown on pages 4 to 15 which illustrates satisfactory cleaning levels.
- We suggest cleaning on a 6-month basis to avoid heavy grease and oil.
